**Tree Inventory, Assessment,  
and  
Protection Report**

**16195 George Avenue, Los Gatos  
Los Gatos, CA 95032**

**Town of Los Gatos**

**August 9, 2021**

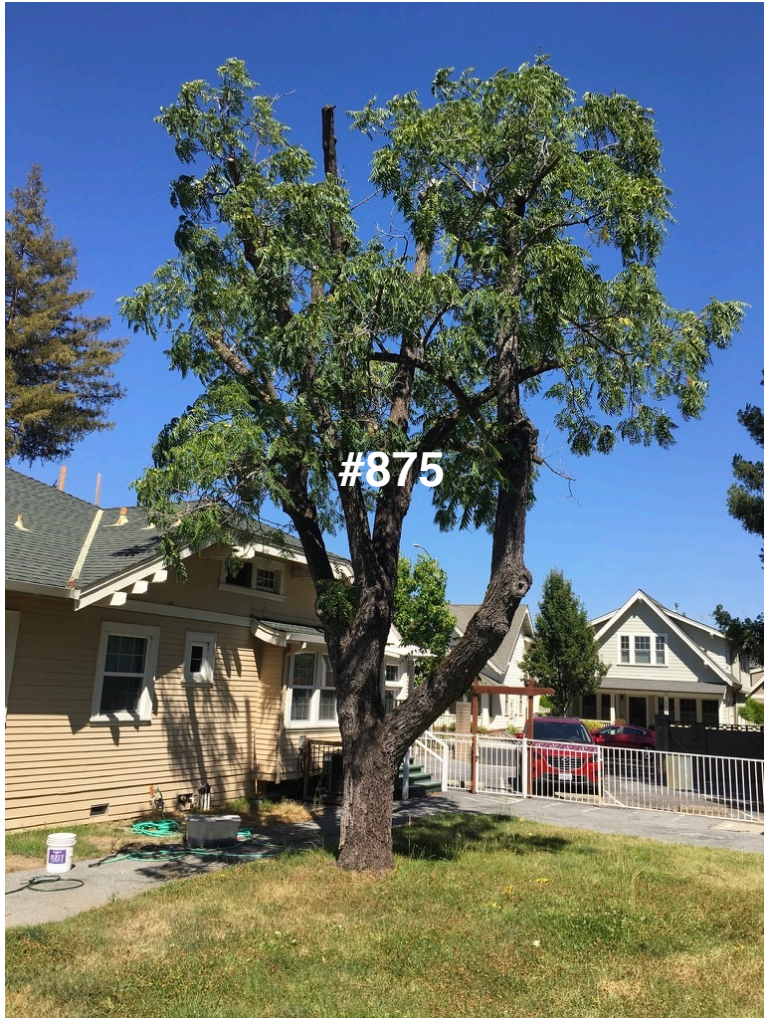
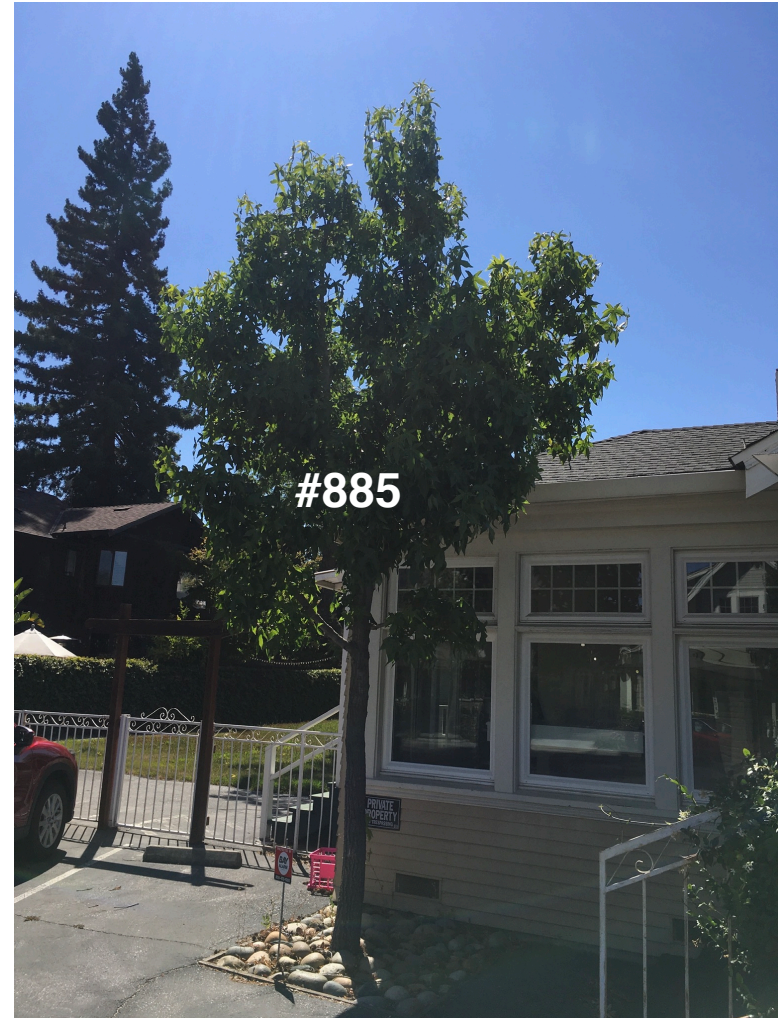
### C1: Black walnut #875 and sweetgum #885

Walnut #875 and sweetgum #885 are both poor condition. The mulberries are in fair shape and the two adjacent coast redwoods #884 and #886 are in good condition. The mulberries are all pollarded (type of pruning system that removes all annual growth to “knuckles”).
